Supplement: GIS Mapping of Muncie and Delaware County Water Quality Information

**Muncie Sanitary District
Bureau of Water Quality
2006**

This supplement, *GIS Mapping of Muncie and Delaware County*, provides static maps that depict both chemical and biological parameters. Maps depicting both trends over time and current water quality are presented.

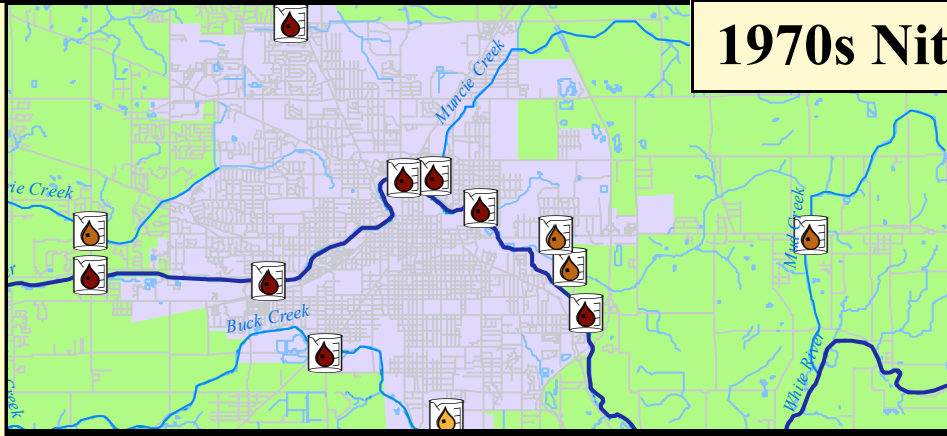
BWQ: White River Nitrate Assessment

Nitrate (NO₃) concentrations have seen large reductions from their 1970s values. Ball Road (Holt Ditch) witnessed a 95% reduction. Several sites have reductions equal to or greater than 70%, including S.R. 32 East (32 Ditch, 87%), West Riggin Road (Greenfarm Ditch, 81%), 400 West (York-Prairie Creek, 77%), Highland Avenue (Muncie Creek, 76%), Tiltotson Avenue (White River, 74%), Cowan Road (Buck Creek, 73%), Memorial Drive (White River, 70%), and Walnut Street (White River, 70%). Remaining sites had the following reductions: Butterfield Road (Truitt Ditch, 62%), Nebo Road (White River, 62%), Ebright Street (Lennox Ditch, 56%), and S.R. 32 East (Mud Creek, 47%),

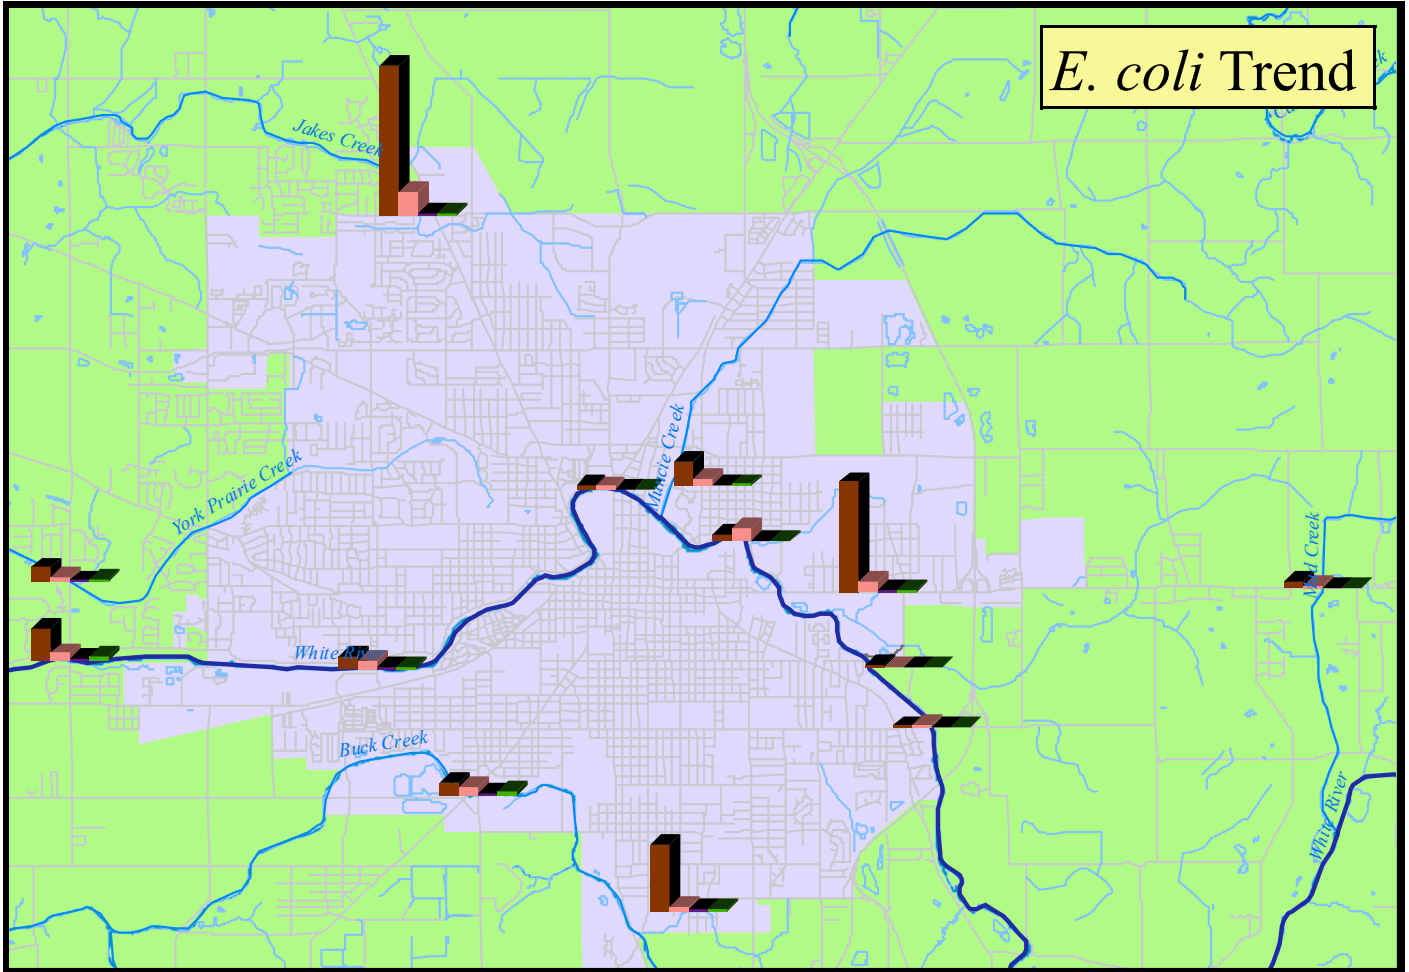
BWQ: White River *E. coli* Assessment

Please note that *E. coli* concentrations for the 1970s and 1980s are estimated figures. The BWQ monitored fecal coliform levels during these decades. A conversion, supported by BWQ simultaneous testing, determined that *E. coli* counts were approximately 62% of fecal coliform concentrations. This was used to determine estimated values.

E. coli concentrations have been significantly reduced from 1970s levels at all city baseline sites. Several sites witnessed reductions equal to or greater than 90%. These include West Riggin Road (Greenfarm Ditch, 99%), S.R. 32 East (32 Ditch, 98%), Ebright Street (Lennox Ditch, 97%), Highland Avenue (Muncie Creek, 91%), and S.R. 32 East (Mud Creek, 90%). Several sites had reductions equal to or greater than 80%, including Tillotson Avenue (White River, 89%), Butterfield Road (Truitt Ditch, 88%), Nebo Road (White River, 87%), Ball Road (Holt Ditch, 85%), Walnut Street (White River, 84%), and 400 West (York Prairie Creek, 80%). Other significant reductions included Cowan Road (Buck Creek, 73%) and Memorial Drive (White River, 59%).

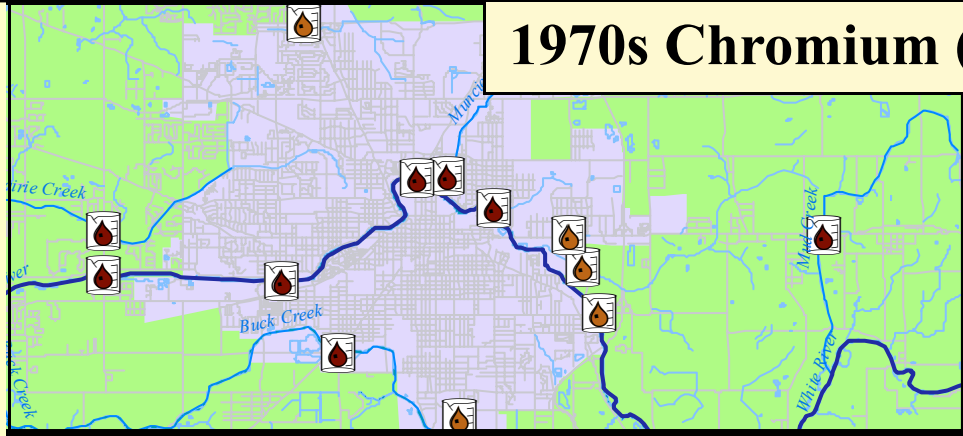
BWQ: White River Chromium (Cr) Assessment

Significant reductions in chromium concentrations from the 1970s to the 2000s were observed at every city baseline site. The highest reduction, 94%, was found at Highland Avenue (Muncie Creek). Most sites displayed reductions greater than 80%. These sites included Ball Road (Holt Ditch, 88%), Ebright Street (Lennox Ditch, 87%), West Riggin Road (Greenfarm Ditch, 86%), Walnut Street (White River, 86%), Cowan Road (Buck Creek, 84%), Memorial Drive (White River, 84%), Tillotson Avenue (White River, 84%), 400 West (York Prairie Creek, 84%), and Nebo Road (White River, 83%). Other significant reductions included Butterfield Road (Truitt Ditch, 77%), S.R. 32 East (Mud Creek, 76%), S.R. 32 East (32 Ditch, 75%).
